Clearing the *Beautiful Blue Danube*

BY TOSA NINKOV, PHD, SE

GPS and geomagnetic surveying makes the Danube River safe again.

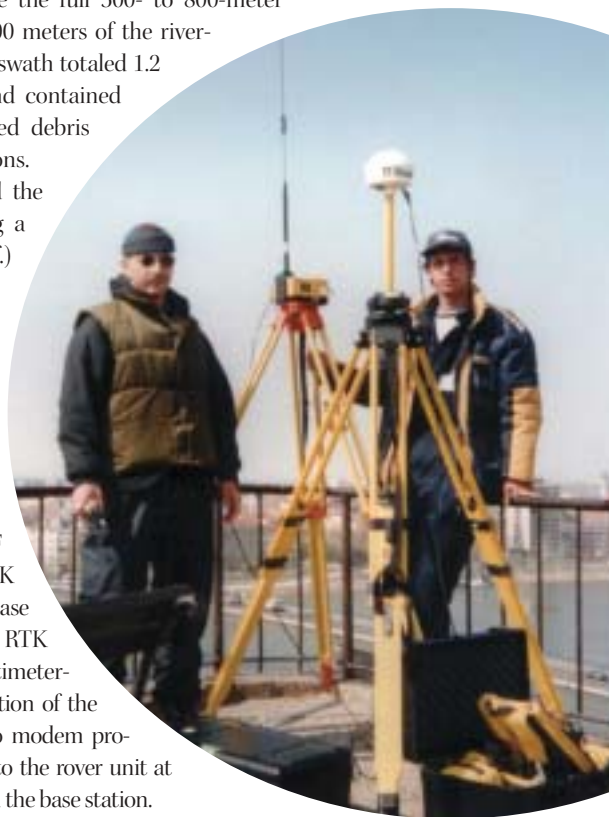
Dr. S. Mihailovic (geophysical expert) and Dj.Ninkov on station with a Trimble Pathfinder and TRIMTALK 450S UHF radio modem as base station for navigation during geophysical investigations.

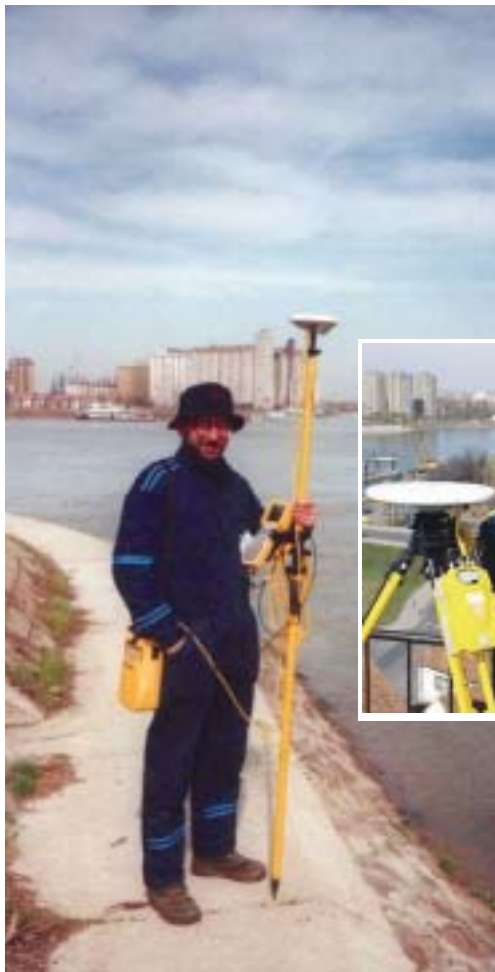
Dipl.Inz. of Surveying, C. Krulj, uses a Trimble 5700 GPS system for RTK measurements on the Danube River project.

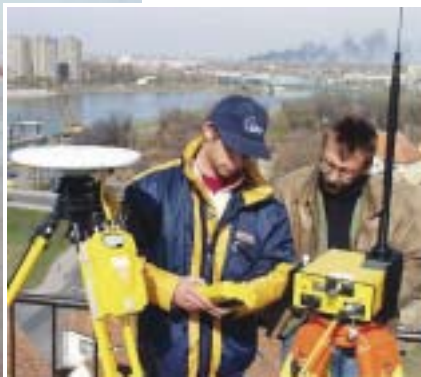
Dj.Ninkov and C. Krulj use the Trimble 5700 GPS Base Station and TRIMTALK 450S UHF radio modem for RTK measurements.

The riverbed map and the DTM were created using a Trimble (Sunnyvale, Calif.) 5700 RTK GPS base station, which was placed on known control points in a project control network covering the entire area. A 5700 RTK GPS rover system was mounted in the survey boat. A Trimble TRIMTALK 450S UHF radio modem provided RTK corrections between the base station and rover units; the RTK corrections provided centimeter-level accuracy for the location of the acquired points. The radio modem provided a wireless data link to the rover unit at distances up to 10 km from the base station.
